PLASTIC PACKAGE AVAILABILITY (PPA) PROGRAM

Final Technical Report for Period October 1992 - November 1995

PLASTIC PACKAGE AVAILABILITY PROGRAM

FINAL REPORT

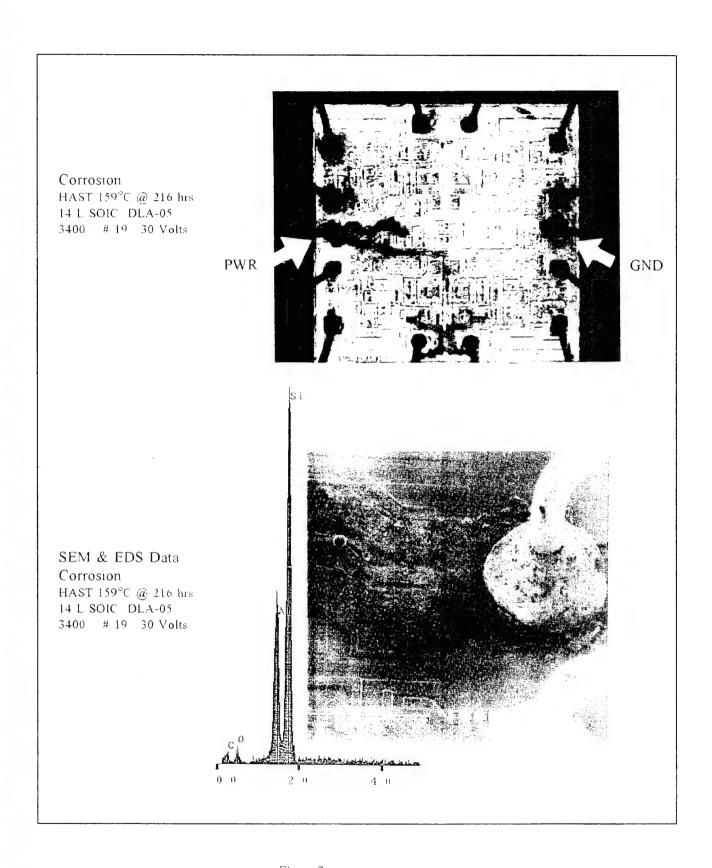
Figure 7

Taken from F/A report, Section 9. Shows gross corrosion on bond pads and circuit metallization after 216 hrs. of HAST at 159°C.

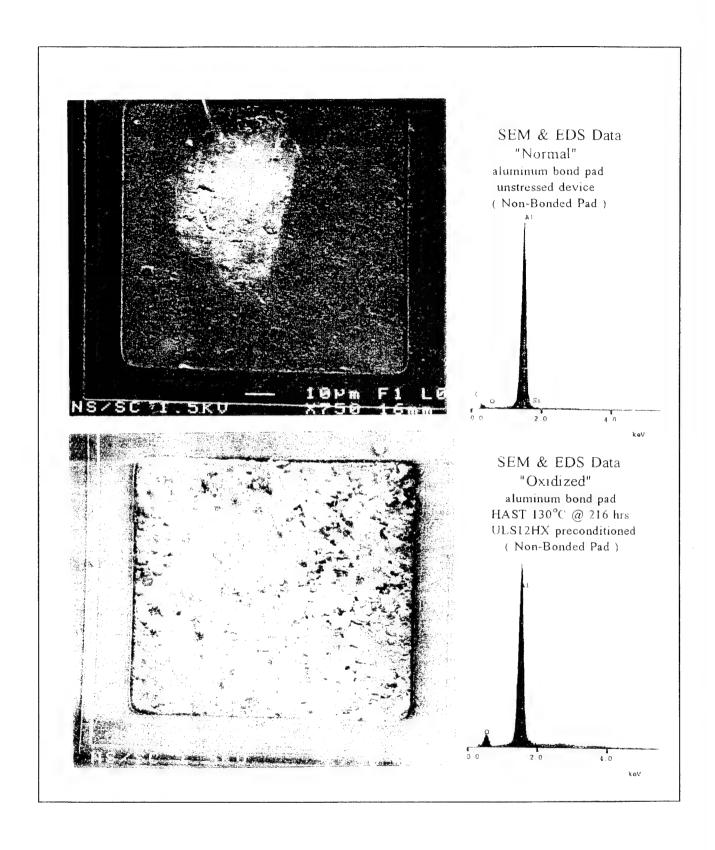
Figure 8 shows bondpad corrosion of a failed HLC plastic device after 216 hrs. of HAST. The bondpad metalization on the SCX6244 die is aluminum-silicon-copper, compared to pure aluminum for the LLC (this might account for the different appearing corrosion between the LLC and HLC devices; also the LLC corrosion appears more severe). This corrosion was the most prevalent failure mode identified in the HLC failures and again is related to moisture, accelerated by temperature, as shown in Figure 30 (PLCCs @ 130 °C vs. 159 °C), and preconditioning as shown by comparing Figures 30 & 31 (PLCCs w/o & w/preconditioning).

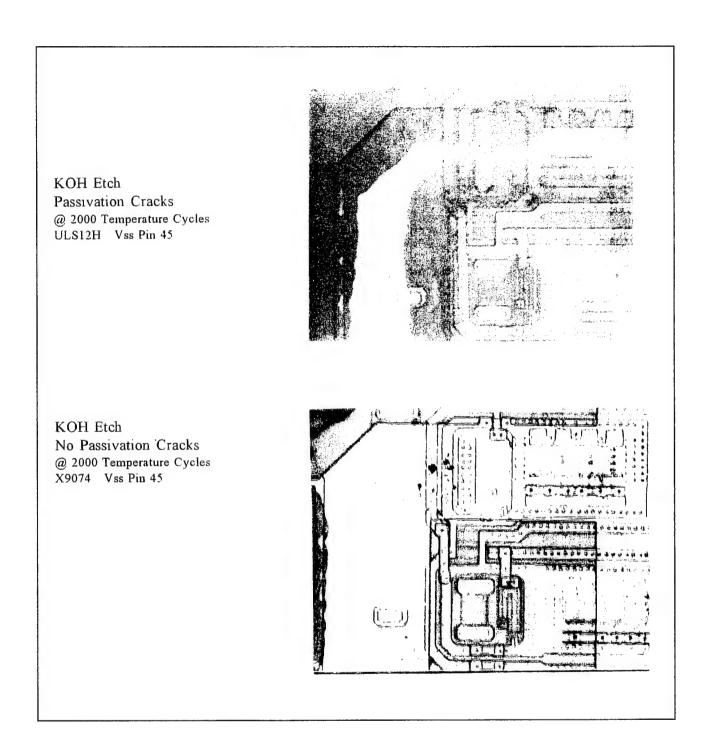
Figure 9

Taken from F/A report, Section 9. Shows evidence of dielectric stress cracking.

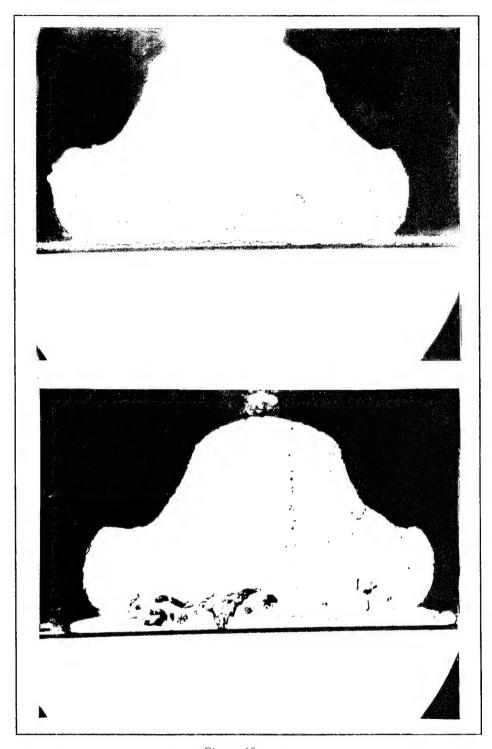
Figure 10 shows the formation of gold-aluminum intermetallic at the gold ball-aluminum bondpad interface of a <u>non-failed HLC</u> device after 4125 hrs. of high temperature storage. No failures were generated by HTS as shown by the graph in Figure 25, High Temperature Storage @ 175 °C for PLCC vs. CQJB, for the standard room-temperature electrical readouts; however, when the same devices were tested at 125 °C, 26/47 showed gross-functional failure. The results of the 125 °C test by mold compound showed the X9074 anti-popcorn to be far superior to the other compounds for passing gross functional: (see Table 4)

Cross section at 1000X to better show intermetallic (AuxAly) region formed between the gold ball-aluminum bondpad. Top, $0\ hr$. and bottom, $4125\ hr$.

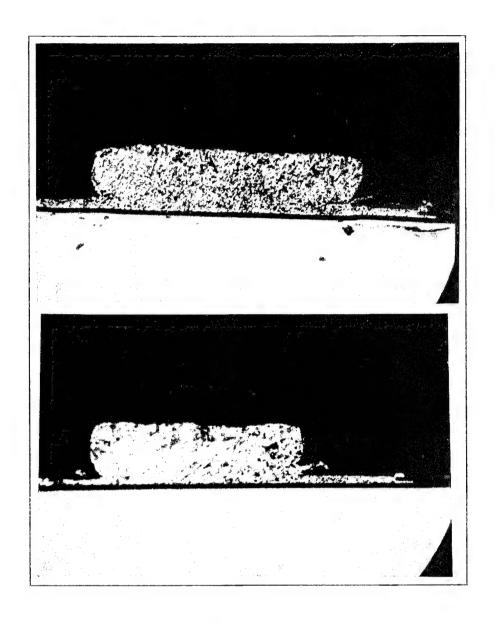
Figure 11

Shows cross-section of aluminum wire bond to aluminum bondpad (for a comparison to Gold Ball-Aluminum Bond Pad cross-section in figure 10) on SCX6244 68L - CQJB, after 0 hr. (top) and 4125 hrs. (bottom) of HTS at 175°C, and lack of intermetallic as expected.

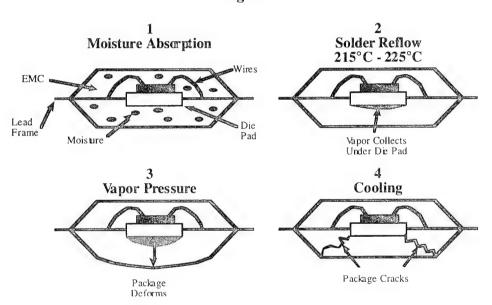
Fig 12

The mechanism of popcorn cracking is shown in Fig 12. A standard epoxy molding compound will typically absorb moisture up to its saturation point of 0.4-0.6%. During solder reflow, the moisture turns to steam thereby exerting pressure on the bottom of the die pad and plastic. This pressure causes bulging of the plastic which leads to package cracking.

The following three characteristics of Plaskon X9074.07 contribute to reduced potential for popcom package cracking .

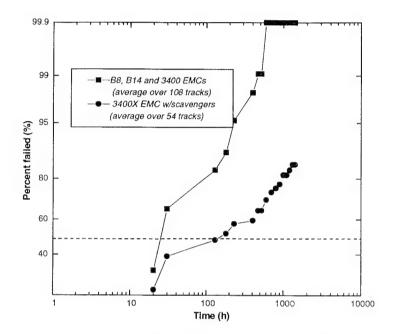
Fig. 19. NAT-01 *unpassivated* CD triple track failure distribution during HAST at 159° C/85% RH and 5 VDC bias on 14-lead DIPs and SOICs molded in Plaskon molding compounds. Plot is log-normal showing failures observed during off-line measurement intervals in a normal probability distribution as a function of log time. Failure data for parts molded in B8, B14 and 3400 compounds without scavengers are grouped and shown as filled squares (\blacksquare), and data for parts molded in 3400X with scavengers are shown as filled circles (\blacksquare). The 3400X parts have a t_{50} of 5-10X greater than the parts without scavengers.

The unpassivated CD was expected to be very sensitive to the state of ionic contamination at the chip surface and within the molding compound. Biased HAST was performed on 14-lead DIPs and SOICs that were molded in 4 different Plaskon molding compounds, 6 parts to a material. One of the compounds, 3400X, had a special ionic scavenger present to reduce ionic contamination. Fig. 19 shows data from this experiment, grouped by -X and non-X compounds to see the effect of ionic scavengers. As can be seen in the chart, the t_{50} (time at which 50% of the parts in a distribution have failed) increased roughly 5–10X for parts molded with the -X compound. Failure analysis showed that electrical failures were due to corrosion of the Al triple tracks in the high electric field region. It should be noted that the data in Fig. 19 are averaged over all triple tracks, both anodic and cathodic.

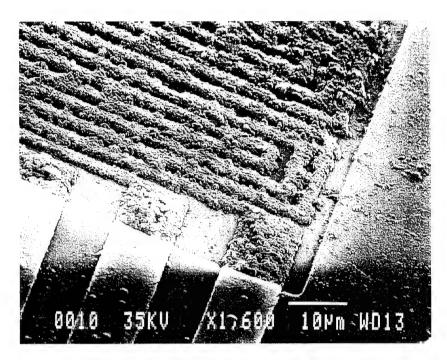
Fig. 20. SEM micrograph of decapsulated NAT-01 *unpassivated* CD that failed during HAST at 159°C/85% RH with 5 VDC bias between tracks. This part was molded in a 14-lead DIP using Plaskon 3400 molding compound.

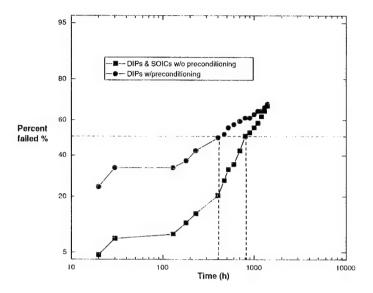
It would be expected that the *passivated* CD would be less sensitive to ionic contamination originating within the molding compound and more sensitive to defects or pinholes in the SiN passivation (or other barrier coating). This is true up to the point at which bondpad corrosion develops and becomes the dominant failure mechanism, which appears to be the case for most of the passivated CD failures. Data from the same HAST experiment described above can be grouped according to preconditioned and non-preconditioned parts, showing the effect of preconditioning on failure rate. This is shown in Fig. 21 for 14-lead DIPs and SOICs, where it can be seen that the preconditioned parts show a reduction in t_{50} of ~50%. One must be careful in ascribing too much to these data, however, as the difference in standard deviations (slopes) of the two series suggest convolution with one or more other failure mechanisms. Failure analysis of these parts showed that the principle failure mechanism was a combination of Au_xAl_y intermetallic formation, associated Kirkendall voiding of interface, and some corrosion

Fig. 21. NAT-01 passivated CD triple track failure distribution during HAST at 159°C/85% RH and 5 VDC bias on 14-lead DIPs and SOICs molded in Plaskon molding compounds. Plot is log-normal showing failures observed during off-line measurement intervals in a normal probability distribution as a function of log time. Non-preconditioned parts are shown as filled squares (\blacksquare), and preconditioned parts are shown as filled circles (\blacksquare). The preconditioned parts show a reduction in t_{50} of ~50%.

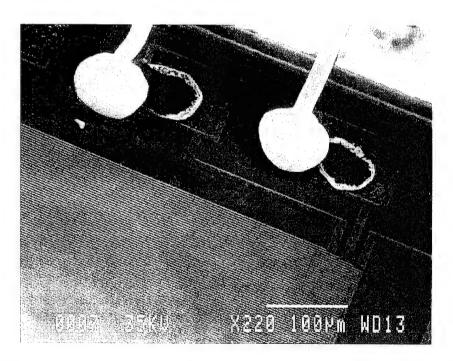
Fig. 22. Decapsulated NAT-01 test chip after 432 hours of HAST by Crane at 159°C/85% RH and 5 VDC bias, showing bondwire/bondpad voiding failure of the passivated CD. Bondwires were moved to the side for clarity. Note voiding in center of bondpads and lack of any signs of corrosion in the high field region of the triple track structure.

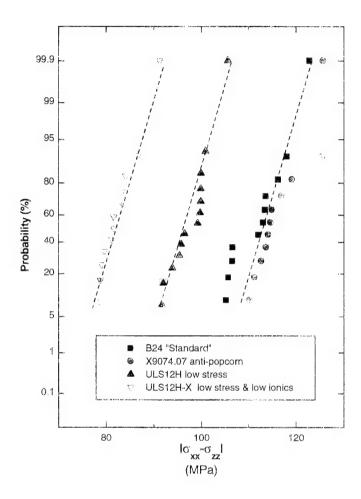
Fig. 27. Average in-plane compressive stress measured with ATC04 test chips molded in 68-lead PLCCs with Plaskon epoxy molding compounds. These data represent changes in stress state due to the die attach and molding operations.

The data in Fig. 27 show a clear trend toward decreasing compressive stress for the low stress formulations, but it was not immediately clear why the ULS12H-X material was so much lower than the ULS12H material. It is informative to predict the stress rankings for these materials using a "stress index" expression, $E\alpha(T_G-T_A)$, where E is the elastic modulus, α is the coefficient of thermal expansion, T_G is the glass transition temperature, and T_A is the ambient temperature. For the materials used in this experiment we get:

Using this stress ranking, we see that the distributions in Fig. 27 basically follow the same trend and, therefore, are in general agreement with expectations based on material properties. No delaminations were evident from C-SAM at this point or after subsequent thermal cycling.

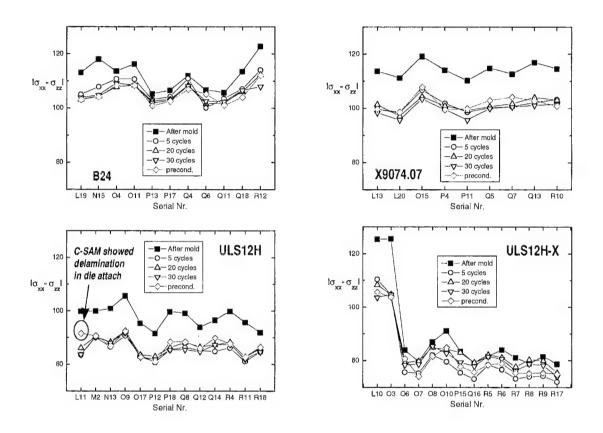
Fig. 28 contains plots of all the stress data recorded during the experiment. Each chart contains data for one of the four molding compounds, plotted as absolute compressive stress as a function of part serial number. Stress measurements underwent a shift in magnitude toward decreasing compressive stress after the first temperature cycle, but maintained the new stress reading through subsequent temperature cycling and IR reflow with the exception of one part –L11. This part, molded with the ULS12H material, had indications of die attach delamination after IR reflow in C-SAM and also a significant jump in average compressive stress reading.

Fig. 28. Average in-plane compressive stress measured by ATC04 test chips molded in 68-lead PLCCs during -65° to +150°C temperature cycle and ~240°C IR reflow simulation. Each data point represents the average of 25 stress cell readings on a single die. Plots are absolute compressive stress vs. part serial number. Symbols in all plots: after mold (\blacksquare), after 5 temp cycles (\bigcirc), after 20 temp cycles (\triangle), after 30 temp cycles (\bigcirc), and after IR reflow (\diamondsuit). Note general relaxation of stress after first temperature cycle across all molding compounds. The two outliers in the ULS12H-X chart are thought to be X9074.07 parts that were mismarked. Part L11 showed delamination of the die attach from C-SAM that correlated with an increase in compressive stress after IR reflow.

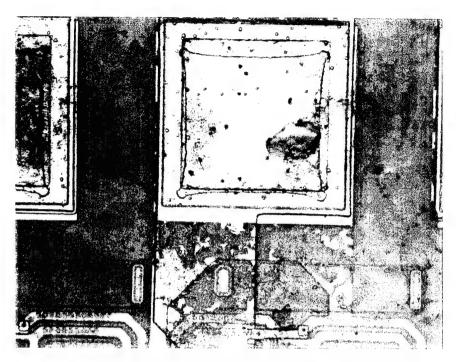
Figure 3. Appearance of the bond pad region after 4 hours of salt fog exposure.

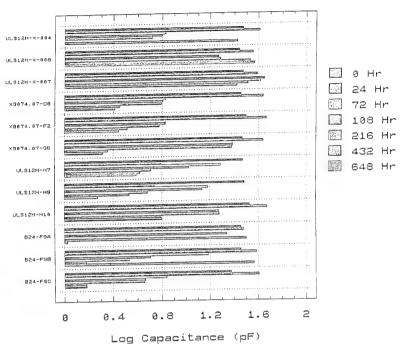
The unpassivated moisture sensor showed increased capacitance and conductance with prolonged exposure; due to the diffusion of moisture or ions from the package into the sensor. The passivated sensors only showed a higher conductance. The devices were baked to return them to the pre-test condition but only the unpassivated showed reversible behavior. Both passivated and unpassivated sensors showed scattered results. The unpassivated sensors seemed more reliable than the passivated ones. Triple track results showed no change of track resistance on all passivated structures for the total 35 hour exposure. All except the unpassivated ULS12HX showed changes over the time exposure. These data may be found in Appendix A for further review.

Figure 10. Cumulative capacitance measurements of MSI unpassivated moisture sensors after 157 °C HAST exposure.

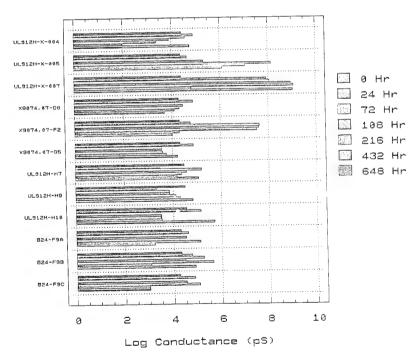
Figure 11. Cumulative conductance measurements of MSI unpassivated moisture sensors after 157 °C HAST exposure.

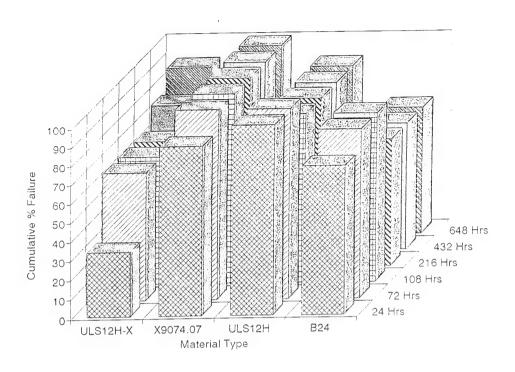
The triple-track corrosion sensors, shown in Figures 14 and 15, revealed more information. The track resistances decayed to opens very rapidly (most of the unpassivated ones within the first 24 hours). The highest rate of failure was the X9074.07 molding compounds in both the unpassivated and passivated cases. The B24 and the ULS12H-X compounds showed the slowest rate of failure.

Figure 14. Cumulative resistance failures of unpassivated triple tracks after 157 °C HAST exposure.

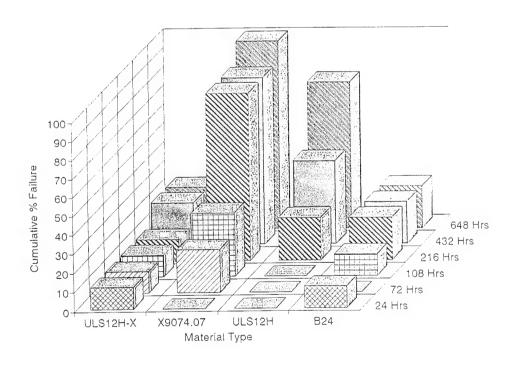
Figure 15. Cumulative resistance failures of passivated triple tracks after 157 °C HAST exposure.

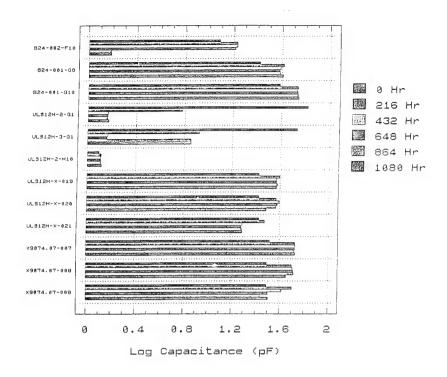
The capacitance values, shown graphically in Figures 16 and 18, were much more stable than in the 157°C HAST. Most devices exhibited little or no change as a result of the test. The ULS12H-X and the X9074.07 compounds were the most erratic (unstable) in the passivated section; there were some large changes from the unexposed values, such as the ULS12H unpassivated material which could be attributed to flaws in the sensor or holes in the passivation. The conductance values, shown graphically in Figures 17 and 19, showed similar behavior.

Figure 16. Cumulative capacitance measurements of MSI unpassivated moisture sensors after 130 °C HAST exposure.

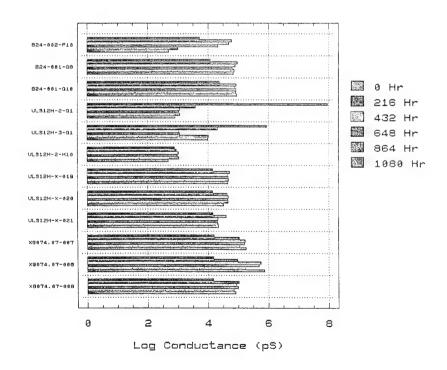
Figure 17. Cumulative conductance measurements of MSI unpassivated moisture sensors after 130 °C HAST exposure.

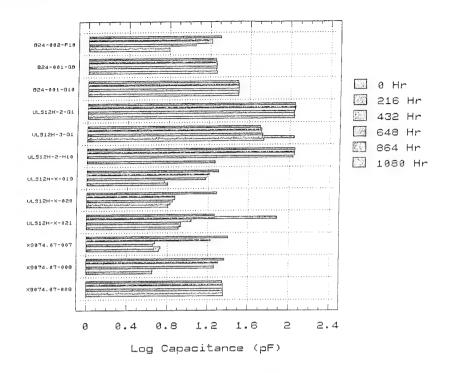
Figure 18. Cumulative capacitance measurements of MSIP passivated moisture sensors after 130 °C HAST exposure.

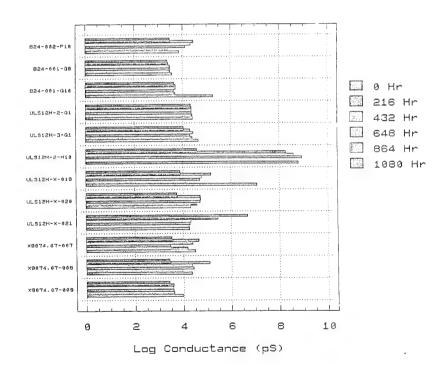
Figure 19. Cumulative conductance measurements of MSIP passivated moisture sensors after 130 °C HAST exposure.

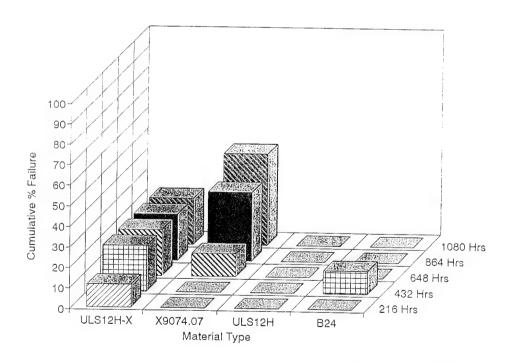
The triple-track measurements, shown graphically in Figures 20 and 21, of the unpassivated sensors rapidly decayed to opens within the first test interval (216 Hrs.). The passivated sensors with the X9074.07 and the ULS12H-X compounds had the highest failure rates.

Figure 21. Cumulative resistance failures of passivated triple tracks after 130 °C HAST exposure.

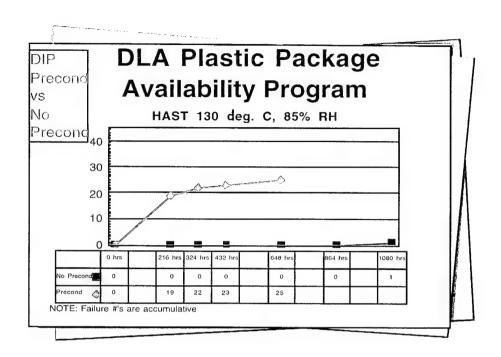
Figure 4 is a chart showing the comparison between the failures of the DIP preconditioned devices and the DIP non-preconditioned devices in 130 degree HAST. The preconditioning tests are performed to simulate manufacturing stresses that the plastic components will encounter. These preconditioning flows are the ones used by National for their commercial components. The DIP devices andthe SOIC devices were preconditioned as shown in figure 5.

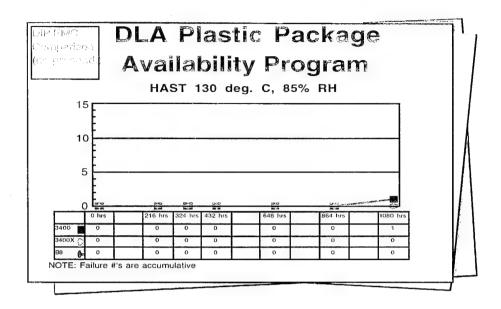
Figure 6 shows a test results comparison between the EMCs used in the DIP package style with no preconditioning tested in HAST at 130 degrees C. As can be seen after 864 hours of HAST, there were no failures that could help distinguish between the three different EMCs. This was one of the reasons for selecting a series of HAST tests at 159 degrees C, to further accelerate the failure to help evaluate the plastic ICs in a more timely manner.

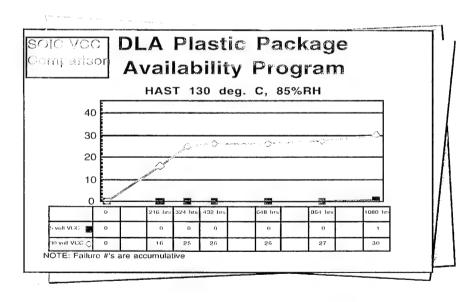
Figure 7 is a comparison of the 130 degree C HAST, 85% RH, SOIC package style, 5 volts VCC versus 30 volts VCC. As can be seen the 30 volts VCC fails sooner than the 5 volt VCC. The 30 volt VCC is within the operating range of the LM124 device.

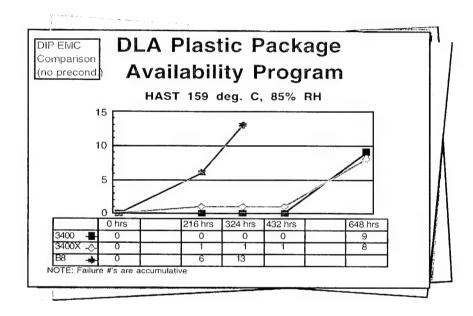
Figure 8 shows a comparison of the three EMCs used in the DIP package with no preconditioning at 159 degrees C HAST. The older National B8 EMC failed first with the Plaskon 3400 lasting much longer. The Plaskon 3400X enhanced EMC show a slight improvement over the 3400 and is much better than the B8. All three preconditioned DIP test lots had reached at least 50% failure at the first data point of 216 hours.

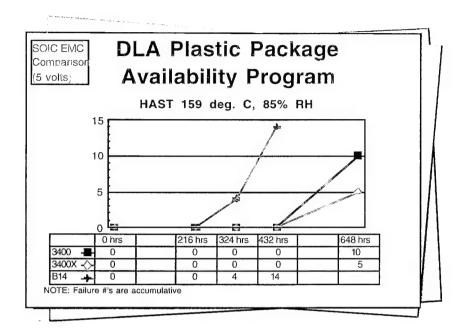
Figure 9 is a comparison of the three EMCs used in the SOIC package at 5 volts VCC at 159 degrees C HAST with 85% RH. The older National B14 SOIC EMC failed first with the Plaskon 3400 lasting much longer. The Plaskon 3400x enhanced EMC shows a marked improvement over the 3400 and is much better than the B14. All three of the SOIC test lots at 30 volts VCC had reached at least 50% failure at the first data point of 216 hours.

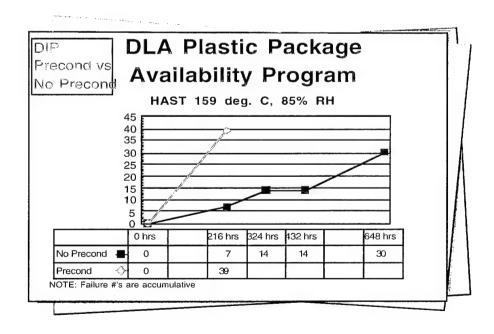
Figure 10 is a comparison of the three DIP lots that were preconditioning versus the three DIP lots that were non-preconditioning at 159 degrees HAST with 85% RH. As can be seen from the test results preconditioning can make a significant difference in the HAST test results. At the time this report was being prepared we do not fully understand the cause of the accelerated failures of the preconditioned devices. A customer buying PEMs should be aware of the type of preconditioning tests that are performed on the devices that they will be purchasing.

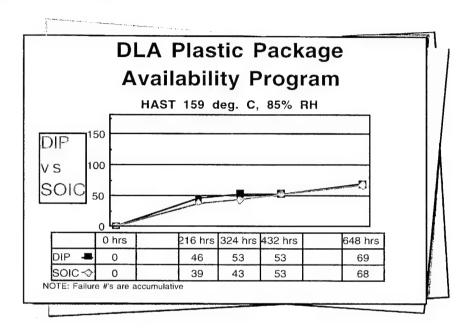
Figure 11 compares the total number of failures of the DIP package versus SOIC package types in 159 degree HAST with 85% RH. This includes 90 DIP devices and 90 SOIC devices for a total of 180 devices. As can be seen from the chart, the package style, at least in this case, did not effect the HAST failure rates. This may not be true for all package styles and should be another factor that the PEM customers must be aware of.

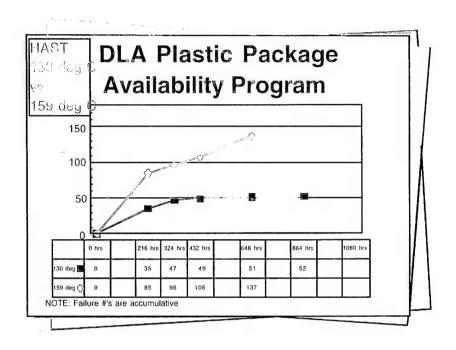
Figure 12 compares the total number of 130 degree HAST failures (out of 180) to the total number of 159 degree HAST failures (out of 180) with 85% RH. Naturally the 159 degree HAST failure rate is higher than the 130 degree HAST but not as high as some acceleration factors would indicate with the 29 degree C temperature difference.

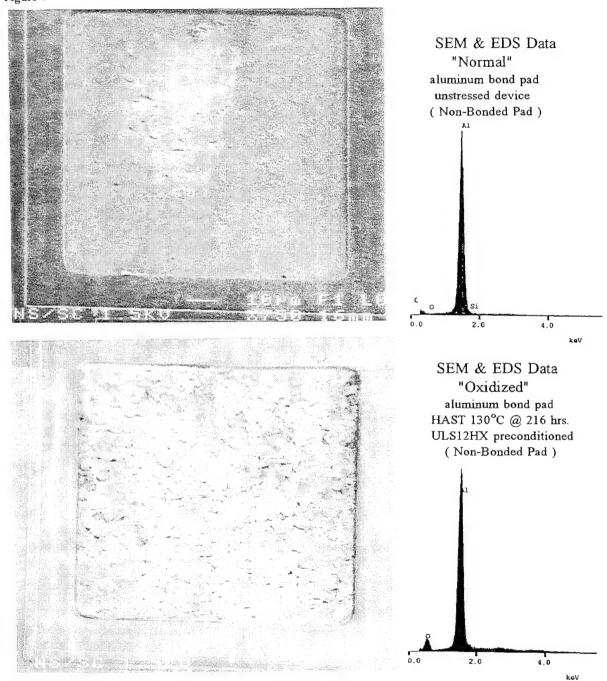
Figure 7 shows the typical surface of the aluminum bond pads from preconditioned 130°C HAST failures @ 216 hours. The SEM/EDS data indicates that the bond pads have oxidized.

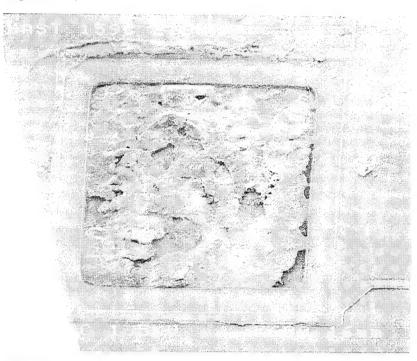
Figure 8

Plastic packages molded with ULS12H, X9074, and B24 were processed through F/A as shown in figure 4. Ball shear data for packages which failed 159°C HAST @ 72 hours are listed in Table 1. SEM inspections on preconditioned 159°C HAST failures revealed several corroded aluminum bond pads (figure 8). The EDS data is shown in figure 9.

Corroded Aluminum
Bond Pad
HAST 159°C @ 216 hrs.
X9074 # 15 preconditioned
(Non-Bonded Pad)

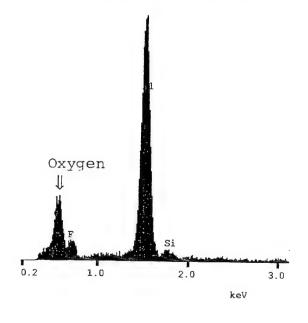
Figure 9

EDS Data
Corroded Aluminum
Bond Pad
HAST 159°C @ 216 hrs.
X9074 # 15 preconditioned

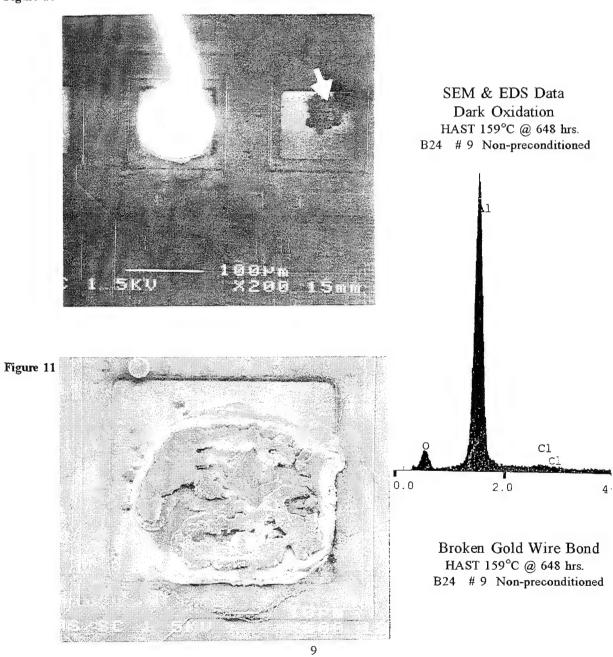
Figure 10

Plastic packages molded with ULS12HX and B24 were processed though F/A as shown in figure 4. The first failures from non-preconditioned 159°C HAST occurred at 648 hours. Typical SEM/EDS data for non-preconditioned 159°C HAST failures are shown in figure 10. Note the dark oxidized material on the aluminum bond pad in figure 10. The fracture surface of a broken gold wire bond is shown in figure 11. Note that part of the aluminum bond pad has been removed. This was the only wire bond that was separated from the bond pad. Three out of five failed devices had broken bonds. The jet etch used in our F/A rarely removes reliable wire bonds.

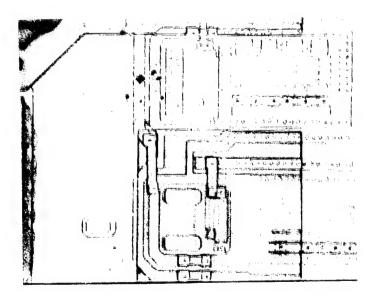
KOH Etch No Passivation Cracks @ 2000 Temperature Cycles X9074 Vss Pin 45

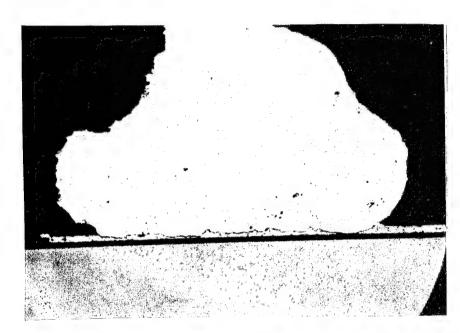
Figure 16 shows the metallographic cross-sections of two gold wire bonds. Staining techniques delineated several intermetallic phases.

Cross-Section
Through Gold
Ball Bond
unstressed sample
0 Hours HTS 175°C
Non-Preconditioned
ULS12H

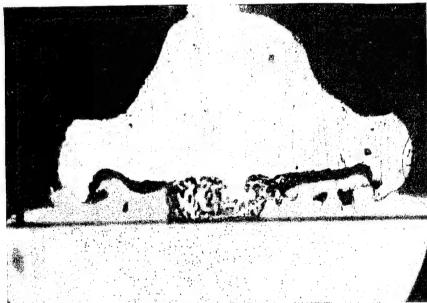
Six packages from HTS @ 4125 hours were decapped (2 plasma, 4 jet etch), and then optically inspected; the wire bonds show no obvious signs of degradation. These six packages were sent for ball shear and pull testing. The ball shear and pull strength data are listed in Table 2. The ball shear and pull strength data indicate that the bonds have degraded. (Normal shear ~ 90 grams, Normal pull ~ 13 grams)

Cross-Section
Through Gold
Ball Bond
Intermetallic Growth
4125 Hours HTS 175°C
Non-Preconditioned
ULS12H

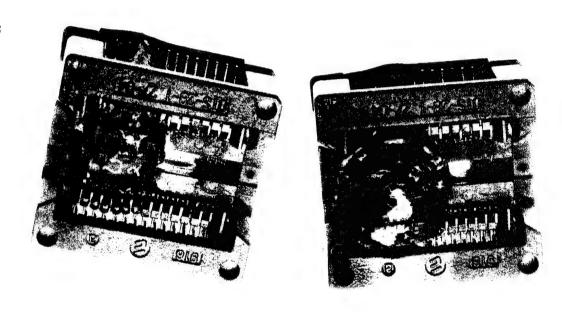
Figure 18

Plastic packages molded with 3400, 3400X, and B14 were processed through F/A as shown in figure 4. Two plastic packages experienced thermal runaway during HAST testing-see figure 18.

Thermal Runaway Failure @ ARLT 130°C HAST

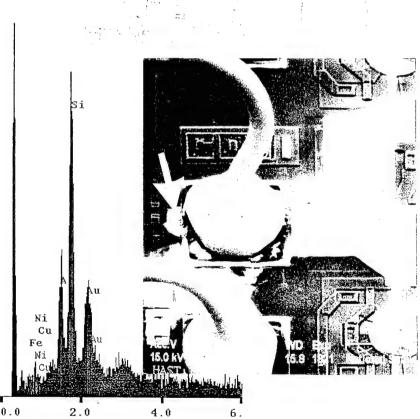
Figure 22

SEM & EDS DATA Gold in the Field HAST 130°C @ 324 hrs. 14 L DIP DLA-02 3400X Preconditioned # 51

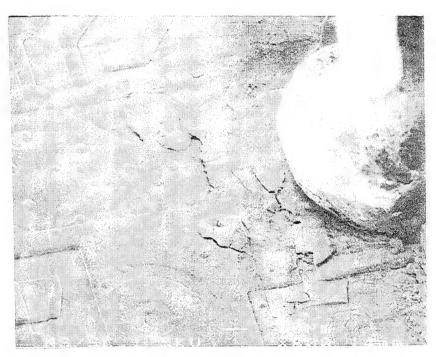
Figure 23

Plastic packages molded with 3400, 3400X, and B14 compounds were processed through F/A as shown in figure 4. Two plastic packages were decapped and inspected. Power pin corrosion was noted on both samples (see figure 23). Packages molded with B14 compound failed at 324 hours. Packages molded with 3400 and 3400X compound failed at 648 hours.

Corrosion
HAST 159°C @ 324 hrs.
14 L SOIC DLA-06
B14 5 Volts
3

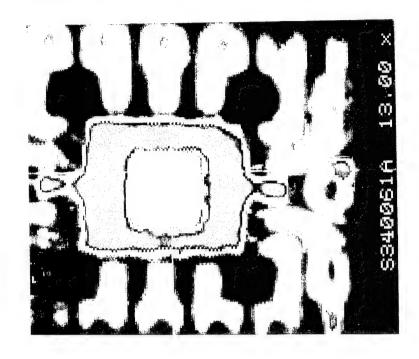
Figure 24

Plastic packages molded with 3400, 3400X, and B14 compounds were processed through F/A as shown in figure 4. CSAM images are shown in figure 24. CSAM images of B14 and 3400X mold compounds show signs of paddle delamination after 216 hours of 159°C HAST.

CSAM Image Delamination HAST 159°C @ 216 hrs 14 L SOIC DLA-06 B14 30 Volts

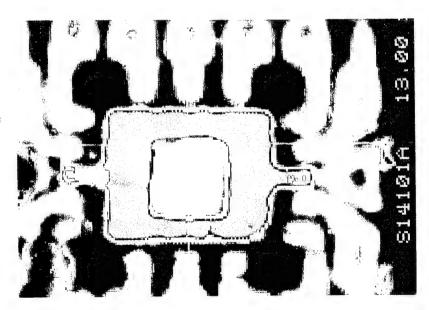
CSAM Image Delamination HAST 159°C @ 216 hrs 14 L SOIC DLA-04 3400X 30 Volts

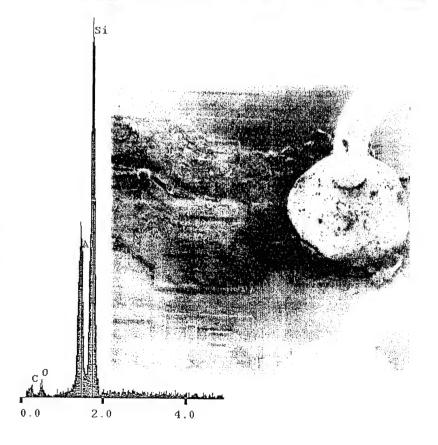
Corrosion
HAST 159°C @ 216 hrs.
14 L SOIC DLA-05
3400 # 19 30 Volts

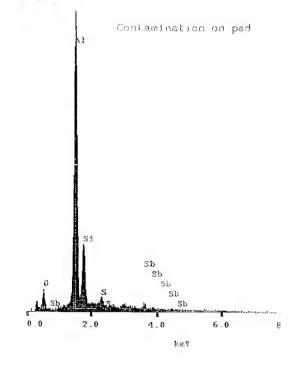
The EDS data taken from the corroded bond pad shown in figure 27 is shown below. Trace amounts (>.5%) of antimony were found on the surface of the power pin bond pad. Antimony is a constituent of the flame retardants used in the test mold compounds. See reference [5] for a discussion of flame retardants and corrosion.

EDS Data
Antimony Peak
HAST 159°C @ 216 hrs.
14 L SOIC DLA-04
3400X # 29 30 Volts

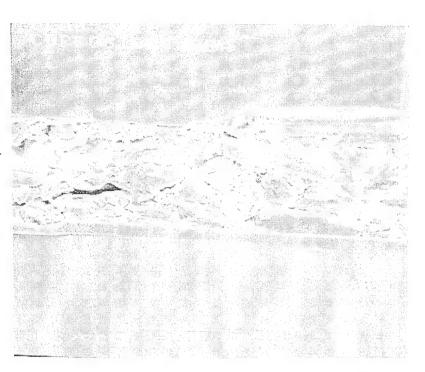
Cross-Section Corroded Pad HAST 159°C @ 216 hrs. 14 L SOIC DLA-05 3400 # 19 30 Volts

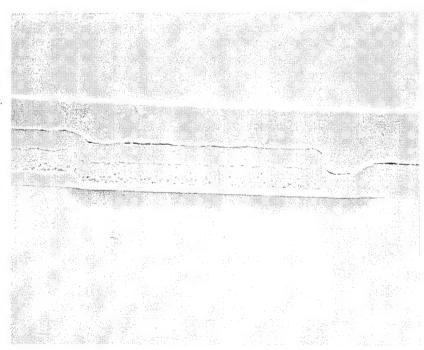
Cross-Section Non-Corroded Pad HAST 159°C @ 216 hrs. 14 L SOIC DLA-05 3400 # 19 30 Volts

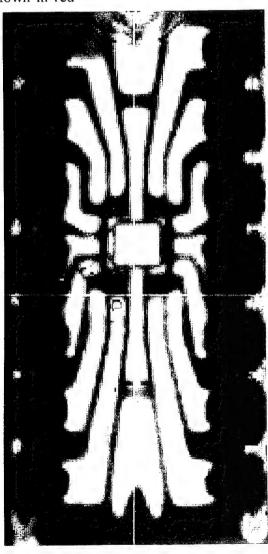
Figure 29

Plastic packages molded with 3400, 3400X, and B8 compounds were processed through F/A as shown in figure 4. CSAM images are shown in figure 29. CSAM images of B8 and 3400 mold compounds show signs of delamination after 216 hours of 159°C HAST.

CSAM Image 159°C HAST @ 216 hrs. 14L DIP DLA-03 B8 Preconditioned Note Delamination Shown in red

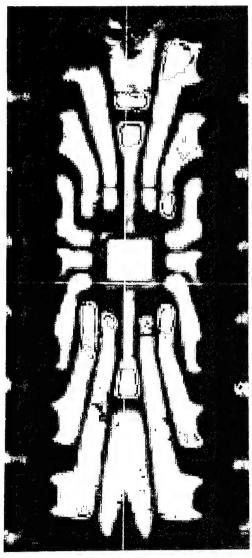
CSAM Image 159°C HAST @ 216 hrs. 14L DIP DLA-01 3400 Preconditioned Note: Delamination Shown in red

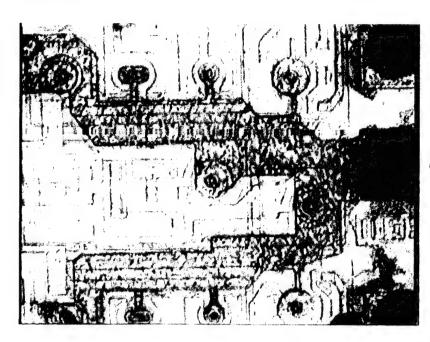
Figure 30

Optical photographs of two failed devices are shown in figure 30. Note the extreme surface damage near the power pin and adjacent field area

Corrosion Near The Power Pin 159°C HAST @ 216 hrs. 14L DIP DLA-02 3400X # 17 Preconditioned
